**Eastern Oregon University Master Plan  
Building & Site Utilities Assessment**

**SERA Architects  
May 30, 2012**

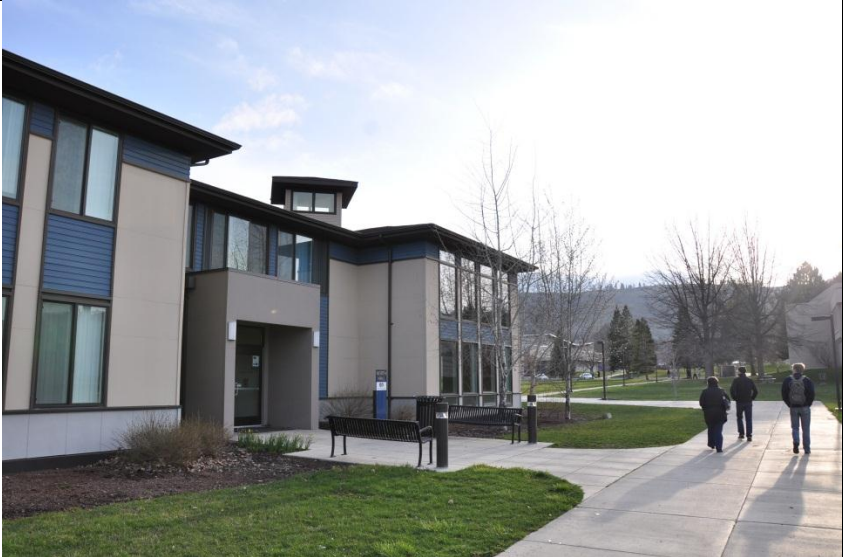
Building Number: 33

Building Name: DH South Dorm / Daugherty Hall	
Year Built: 2006	
Significant Renovations:	
Use/Occupancy: residence hall

Residence life maintenance finds earlier decisions about durability of systems and products cause more maintenance time and cost money. Specific items most troubling to them include the storefront entry systems, vertical blinds, entry level residential toilets, and lack of abuse resistant drywall.

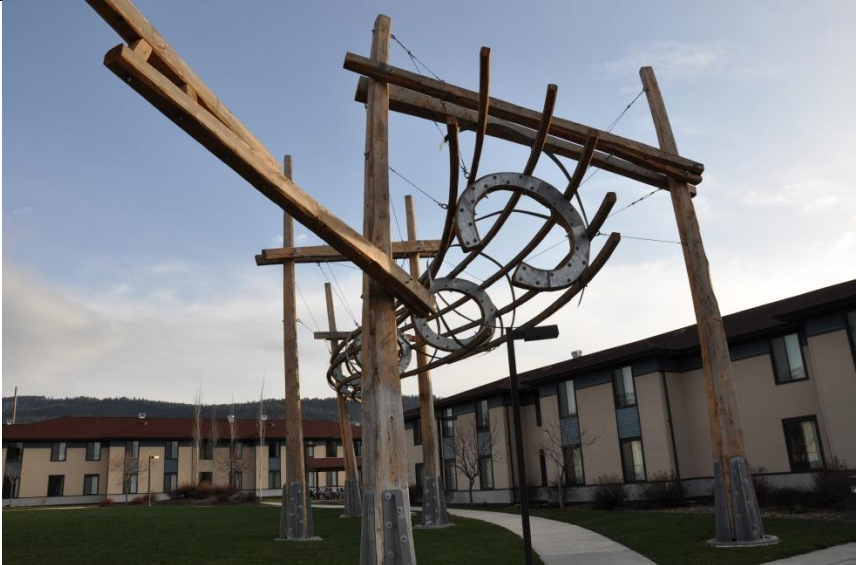
Building Number: 34

Building Name: NH North Hall		
Year Built: 2006		
Significant Renovations:		
Use/Occupancy: residence hall

Residence life maintenance finds earlier decisions about durability of systems and products cause more maintenance time and cost money. Specific items most troubling to them include the storefront entry systems, vertical blinds, entry level residential toilets, and lack of abuse resistant drywall.
